DEPARTMENT OF TRANSPORTATION**DIVISION OF ENGINEERING SERVICES**

Contract #: 04-0120F4Cty: SF/ALA Rte: 80 PM: 13.2/13.9File #: 1.28**WELDING INSPECTION REPORT****Resident Engineer:**Siegenthaler, Peter**Address:** 333 Burma Road**City:** Oakland, CA 94607**Report No:** WIR-022471**Date Inspected:** 06-Apr-2011**Project Name:** SAS Superstructure**OSM Arrival Time:** 700**Prime Contractor:** American Bridge/Fluor Enterprises, a JV**OSM Departure Time:** 1530**Contractor:** American Bridge/Fluor Enterprises, a JV**Location:** Job Site

| Bridge No: | 34-0006 | | | Component: | Orthotropic Box Girder | | |

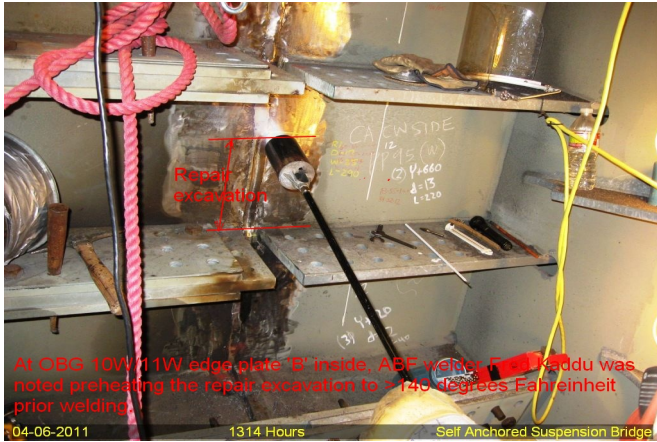
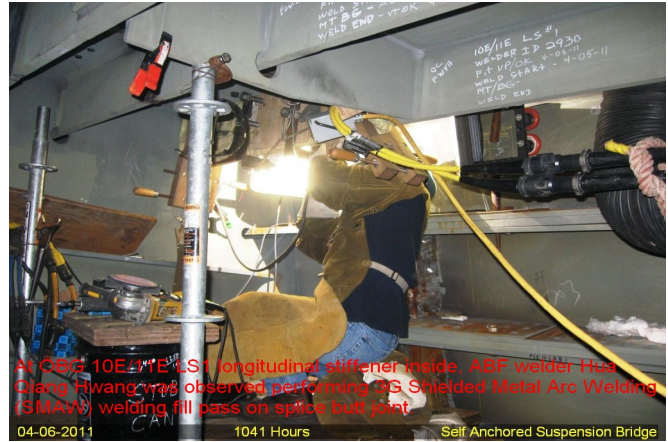
At OBG 10E/11E LS1 longitudinal stiffener inside, QA randomly observed ABF welder Hua Qiang Hwang perform 3G (vertical) Shielded Metal Arc Welding (SMAW) complete joint penetration (CJP) welding root pass to cover pass on the stiffener splice butt joint. The stiffener plates being welded are made of high strength plate material HPS 485W and has a thickness of 30mm. The joint has a double V joint preparation that was welded from one side and after the completion from one side, to be back gouged; Non Destructive Testing (NDT) tested using Magnetic Particle Testing (MT) and back welded to the other side. The welder was noted using E9018H4R with 1/8" diameter electrode implementing Caltrans approved welding procedure specification (WPS) ABF-WPS-D1. 5-1012-3. The joint being welded was root welded using a ceramic backing. The splice joint was preheated to greater than 200 degrees Fahrenheit using Miller Proheat 35 Induction Heating System heater blanket located at the opposite side of the plate prior/during welding. The QA Inspector noted the ABF QC Fred Von Hoff was on site monitoring the in process preheats and welding parameters. During the shift, QA noted ABF QC Fred Von Hoff was closely monitoring the issuance of E9018H4R electrodes due to its limited exposure time allowed. At the end of the shift, cover pass welding was completed on one side of the plate and the welder has moved the heater blanket so he can weld the other side.

QA randomly observed ABF/JV qualified welders Rory Hogan (ID #3186) and Jeremy Dolman (ID #5042) perform CJP groove (splice) back welding fill pass on Orthotropic Box Girder (OBG) 9E/10E side plate 'E1'

At OBG 10W/11W edge plate 'B' inside, QA randomly observed ABF/JV qualified welder Fred Kaddu ID # 2188 perform CJP groove welding repair. The welder was observed welding in the 3G (vertical) position utilizing Shielded Metal Arc Welding (SMAW) with 1/8" diameter E7018H4R electrode implementing welding procedure ABF-WPS-D15-1001-Repairs. The first time repair was located at Y dimension 660mm and was having a repair excavation dimension of 290mm long x 25mm wide x 17mm deep. The repair excavation was preheated to more than 140 degrees Fahrenheit using propane gas torch prior welding. During the shift, ABF QC William Sherwood was noted monitoring the welder. Prior welding, ABF QC William Sherwood was also observed performing Magnetic Particle Testing (MT) on the repair excavation. There was no defect noted during the test. At the end of the shift, welding repair at this location was completed and visually accepted by ABF QC.

At OBG 10W/11W edge plate 'F' inside, QA randomly observed ABF/JV qualified welder Jorge Lopez continuing to perform cover pass back welding on the Complete Joint Penetration (CJP) splice butt joint. The welder was observed manually welding in the 3G (vertical) position utilizing a Shielded Metal Arc Welding (SMAW) with 1/8" diameter E7018H4R electrode and implementing Caltrans approved Welding Procedure Specification (WPS) ABF-WPS-D15-1040B. The joint being welded has a single V-groove butt joint with steel backing bar that has been removed and back gouged. The groove of the ground and gouged area of the backing bar was also tested using Magnetic Particle Testing (MT). During welding, ABF Quality Control (QC) William Sherwood was noted monitoring the welding parameters of the welder. During the shift, cover pass SMAW welding was completed and the welder has ground flush the weld cover reinforcement which was also completed at the end of the shift.

At the request of Quality Control Field Supervisor, Bonifacio Daquinag, QA has randomly verified the QC VT of the Complete Joint Penetration (CJP) welding of four (4) lifting lug access hole to top deck plate butt joints. The QA verification was performed to verify that the welding and the VT inspection performed by the QC inspector meet the requirements of the contract documents. At the conclusion of the QA verification it appeared that the weld and the QC inspection complied with the contract documents.
